DEPARTMENT OF TRANSPORTATION

Contract #: 04-0120F4Cty: SF/ALA Rte: 80 PM: 13.2/13.9File #: 1x.28**WELDING INSPECTION REPORT****Resident Engineer:** Pursell, Gary**Address:** 333 Burma Road**City:** Oakland, CA 94607**Report No:** WIR-014178**Date Inspected:** 18-May-2010**Project Name:** SAS Superstructure**OSM Arrival Time:** 1000**Prime Contractor:** American Bridge/Fluor Enterprises, a JV**OSM Departure Time:** 1830**Contractor:** American Bridge/Fluor Enterprises, a JV**Location:** Job Site

CWI Name:	William Sherwood and Bernie Do			CWI Present:	Yes	No	
Inspected CWI report:	Yes	No	N/A	Rod Oven in Use:	Yes	No	N/A
Electrode to specification:	Yes	No	N/A	Weld Procedures Followed:	Yes	No	N/A
Qualified Welders:	Yes	No	N/A	Verified Joint Fit-up:	Yes	No	N/A
Approved Drawings:	Yes	No	N/A	Approved WPS:	Yes	No	N/A
				Delayed / Cancelled:	Yes	No	N/A
Bridge No:	34-0006			Component:	Orthotropic Box Girder

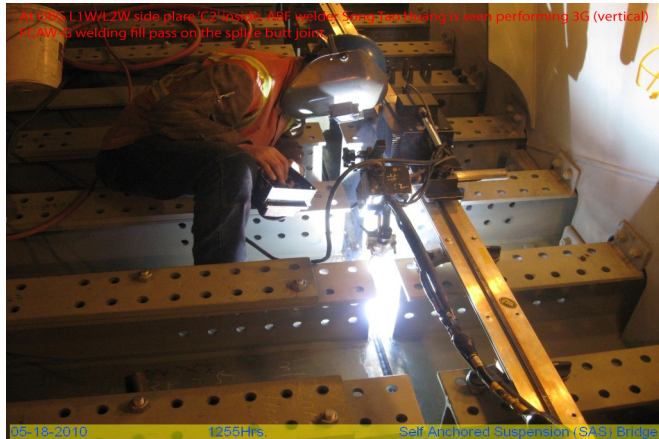
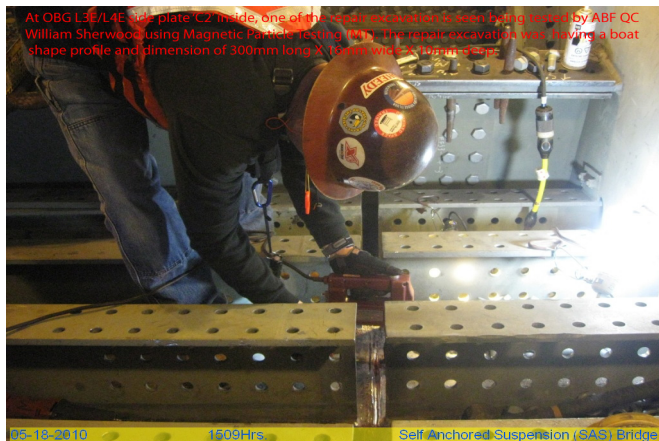
At OBG L3E/L4E side plate 'C2' inside, QA randomly observed ABF/JV qualified welder Mitch Sittinger continue perform CJP groove welding repair. The welder was observed welding in the 3G (vertical) position utilizing Shielded metal Arc Welding (SMAW) with 1/8" diameter E7018H4R electrode implementing welding procedure ABF-WPS-D15-1000-Repairs. The repair excavations were preheated to more than 140 degree Fahrenheit using propane gas torch prior welding. During the shift, ABF QC William Sherwood was noted monitoring the welder. Prior welding, ABF QC William Sherwood was also observed performing Magnetic Particle Testing (MT) using Parker Contour Probe with red magnetic powder as detecting media on the repair excavation. During the shift, the welder has completed three welding repairs inside and was working on the fourth repair at the end of the shift.

At OBG L3E/L4E edge plate 'B' inside, this QA performed a 10% Magnetic Particle Testing (MT) using a Parker Contour Probe electromagnetic yoke with corresponding red magnetic powder as detecting media to the welded splice butt joint. The surface profiles of the joints were as welded and cleaned with wire brush. There were no significant defects noted during the test.

At OBG L2W/L3W side plate 'C2' (5280 to 7900mm) inside, QA randomly observed ABF/JV qualified welder Sungtao, Huang ID # 3794 perform CJP groove (splice) welding root then fill pass. The welder was observed

perform automatic welding in the 3G (vertical) position utilizing a dual shield Flux Cored Arc Welding (FCAW-G) with E71T-1M, 1/16" diameter wire electrode and implementing Caltrans approved Welding Procedure Specification (WPS) ABF-WPS-D15-3042A-1. The joint being welded has a single V-groove butt joint with backing bar. The splice joint was preheated and maintained to greater than 200 degree Fahrenheit using Miller Proheat 35 Induction Heating System located at the opposite side of the plate prior/during welding. During welding, ABF Quality Control (QC) Bernie Docena was noted monitoring the welding parameters of the welder. QA performed parameter readings during welding with the following results; 254 amperes, 24.0 volts and 320mm per minute travel speed which are deemed acceptable to contract specifications.
